BURTON DUENKE #2 LAKE DAM
CAMDEN COUNTY, MISSOURI
MO 31611

PHASE 1 INSPECTION REPORT NATIONAL DAM SAFETY PROGRAM

BURTON DUENKE NO. 2 LAKE DAM

PHASE I INSPECTION REPORT
NATIONAL DAM SAFETY PROGRAM

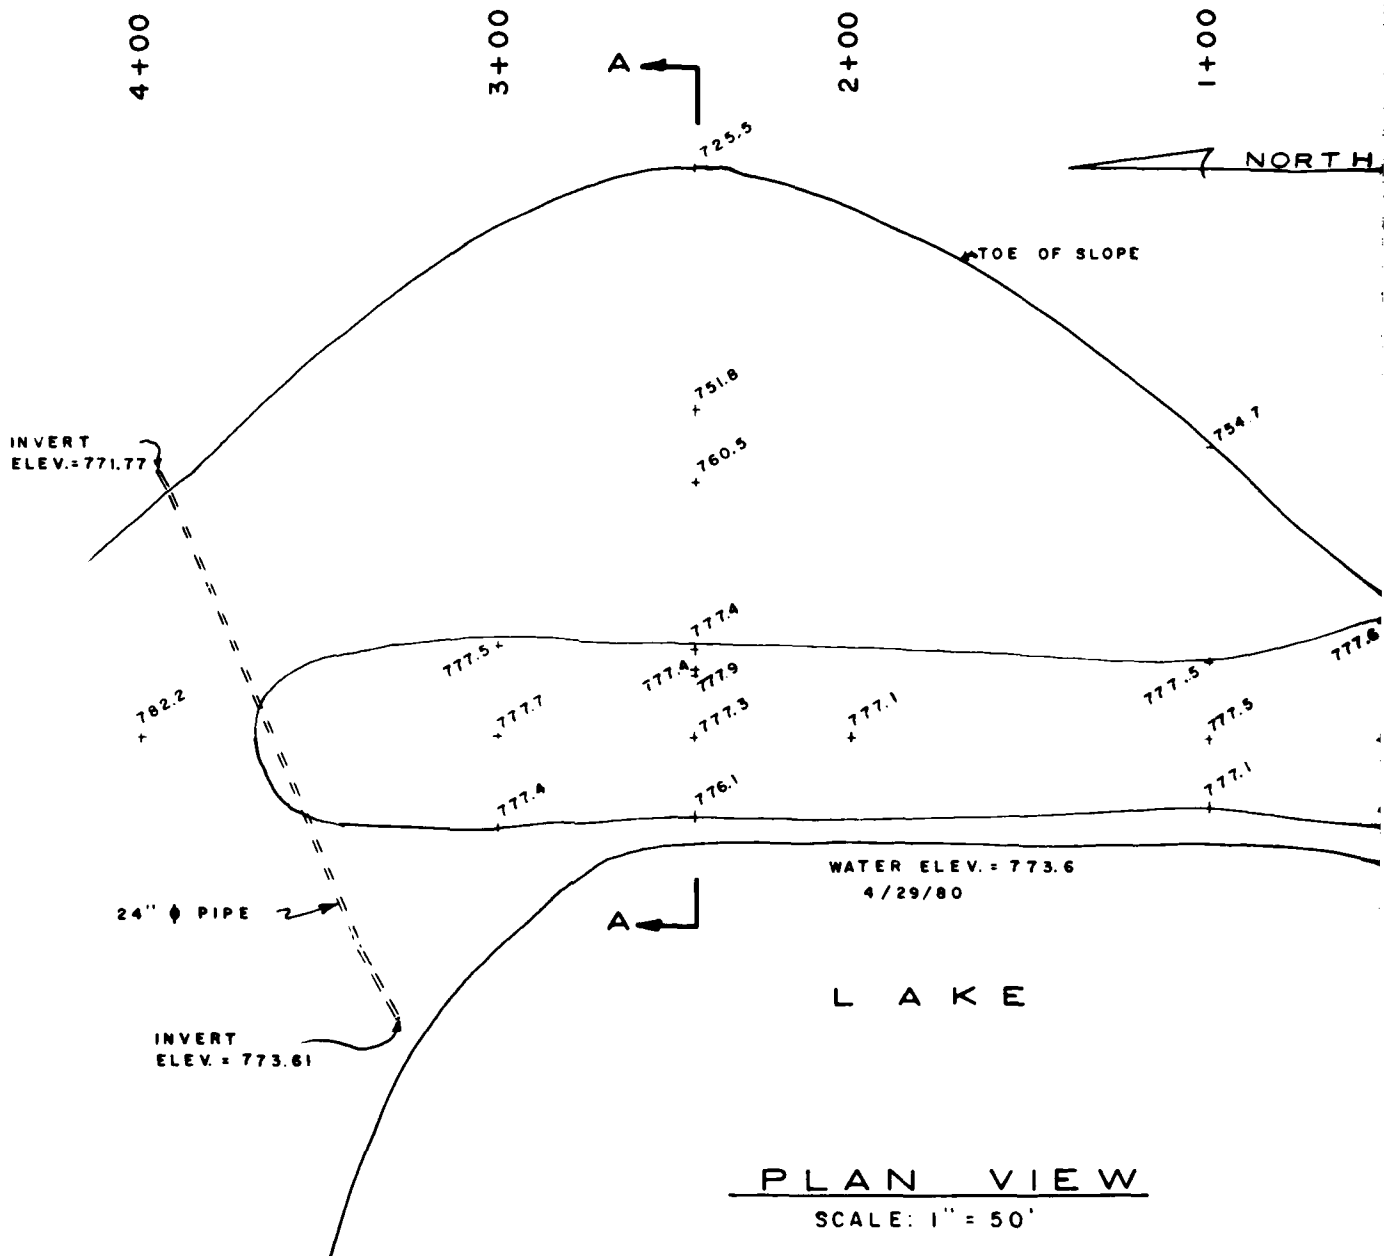
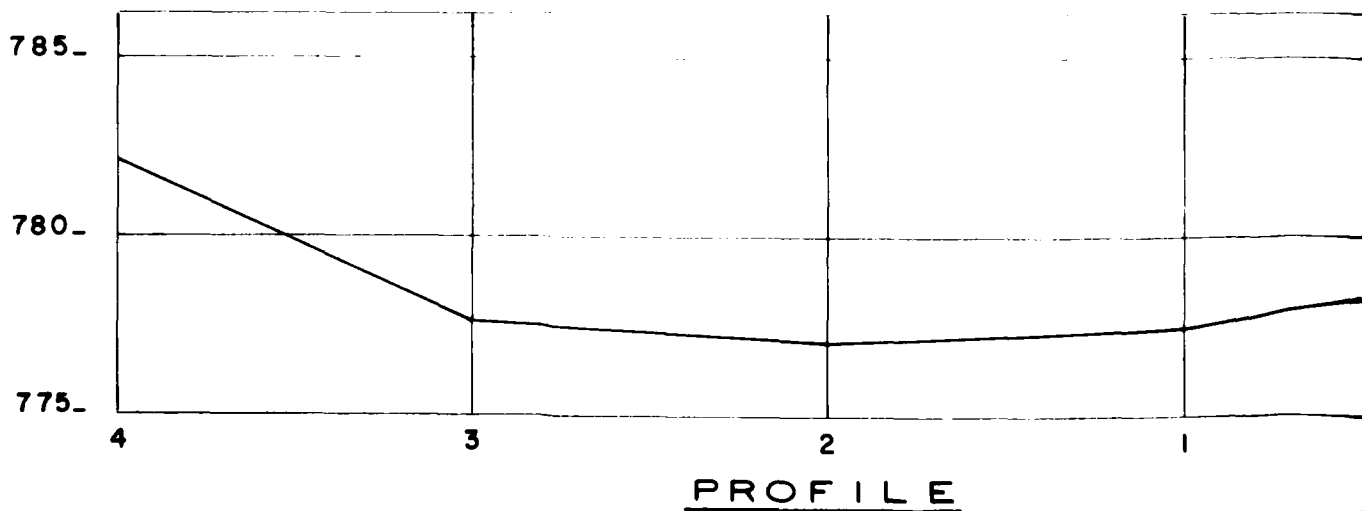
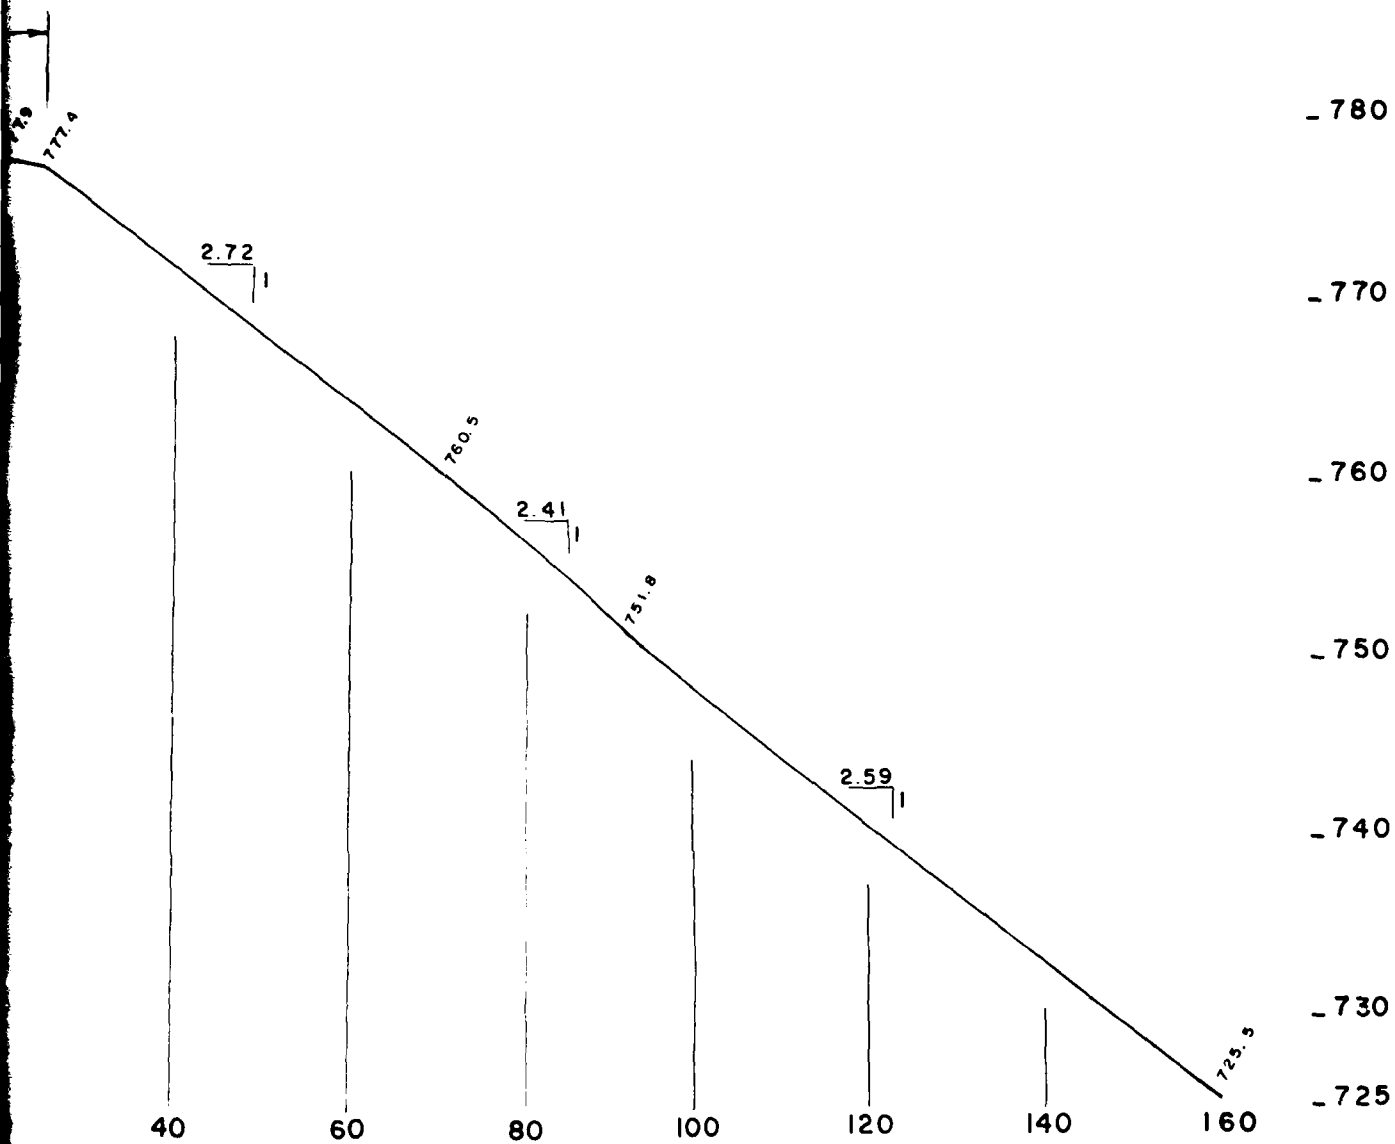
SHEET 3 APPENDIX A

SECTION A-A STA 2+45

BENCHMARK.
24" ϕ CMP INLET INVERT
ELEV. = 773.61
